## Central Station Dresden

General renovation and reconstruction of the station building

General renovation and reconstruction of the station building of the historic Central Station in Dresden built in 1895, was an urgent need after the floods from 2002 in order to assure the building’s stability and keep it operable.

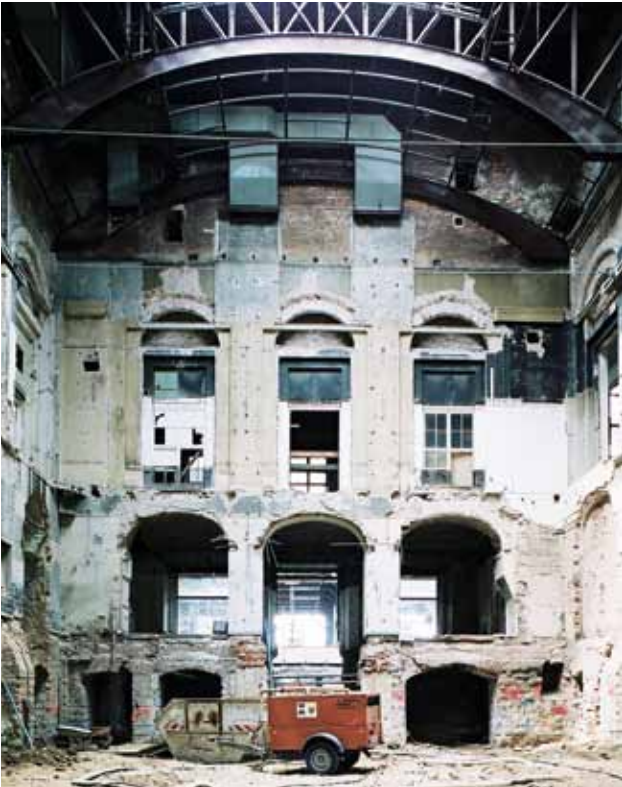
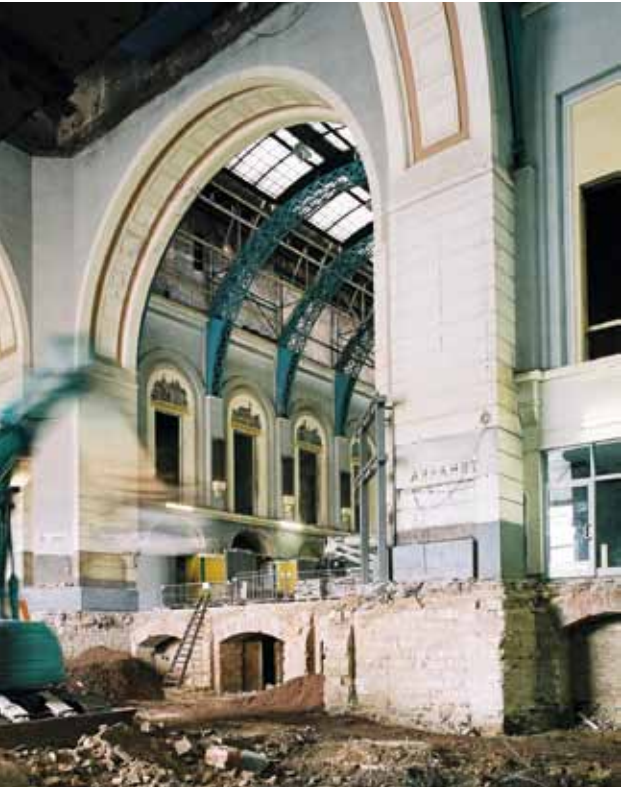
**left: Demolition** south waiting hall  
**right: Demolition** basement at passenger area

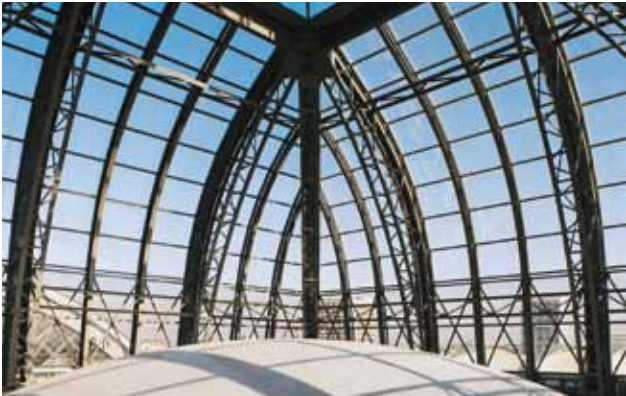
Interior view dome truss

The primary steel truss, supported on the central masonry arches of the station hall, was renovated in-situ and a new corrosion protection layer was applied. The glassing of the historic dome truss was, analogous to the membrane roof of the platform halls, assembled to the truss members of the primary truss by installation of a statically and geometrically connecting spatial secondary steel substructure. To achieve a high grade of prefabrication with regard to the existing tolerances of the primary truss, a high degree of detailing was necessary during final design of the spatial steel substructure as well as the connections of the glassing.

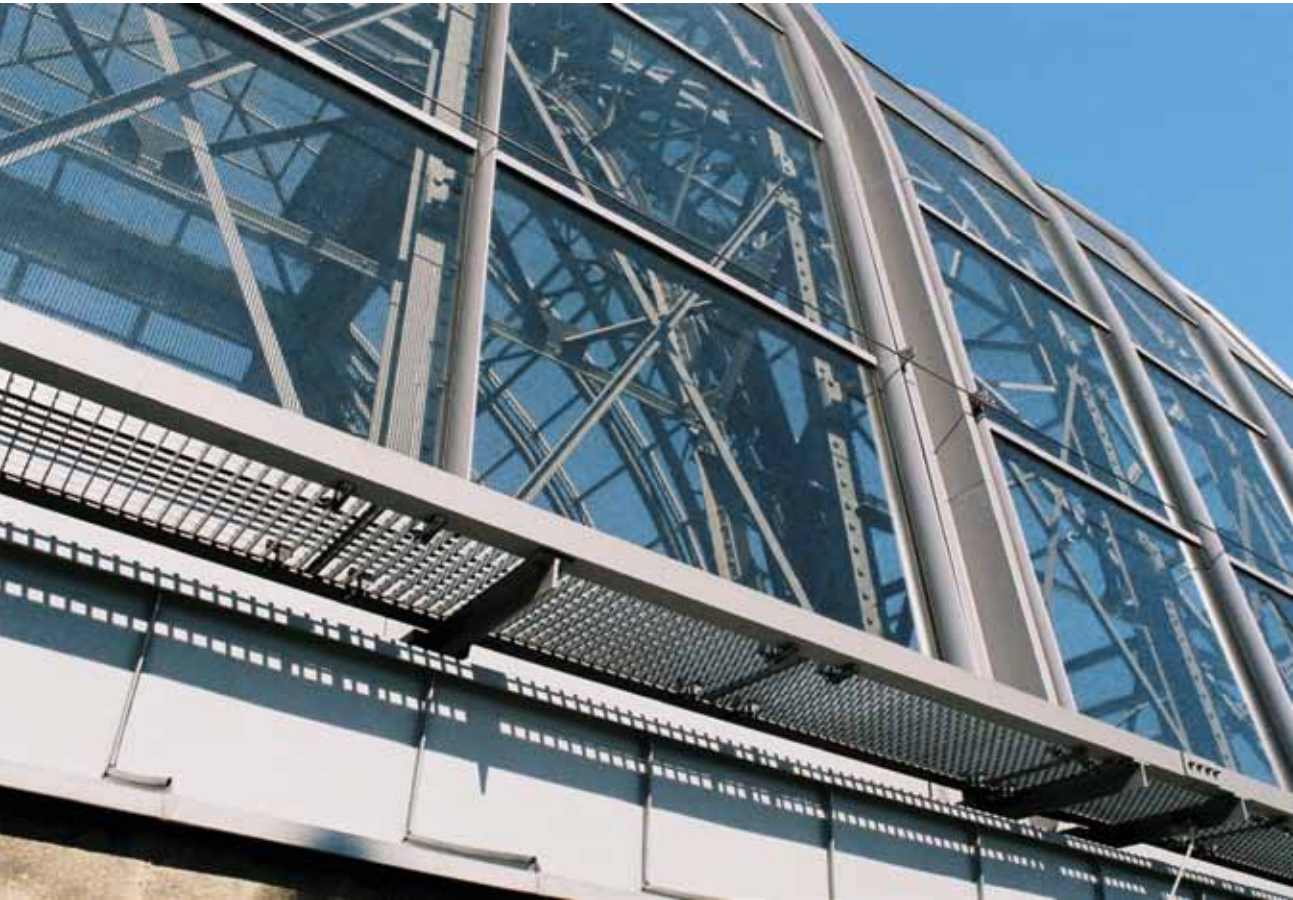
Detail dome truss with maintenance catwalk

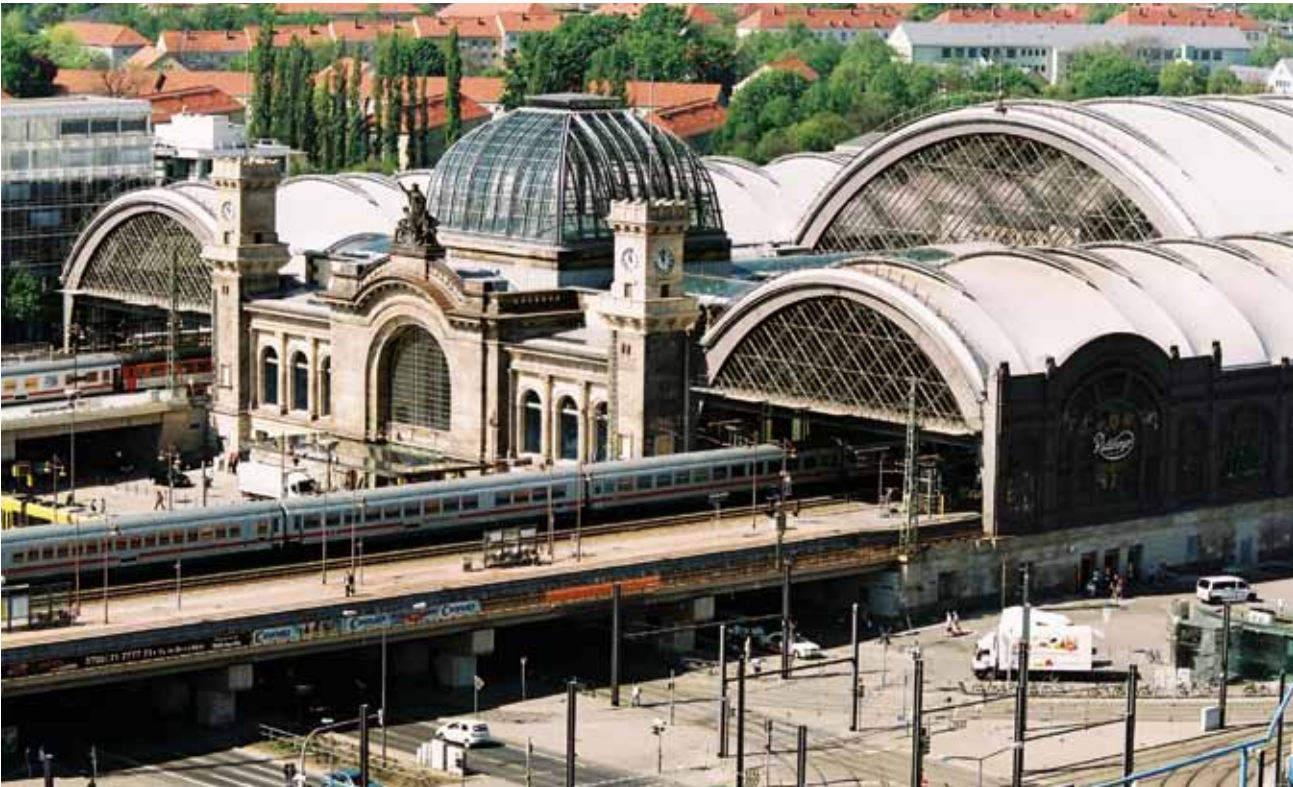
Construction stage station building

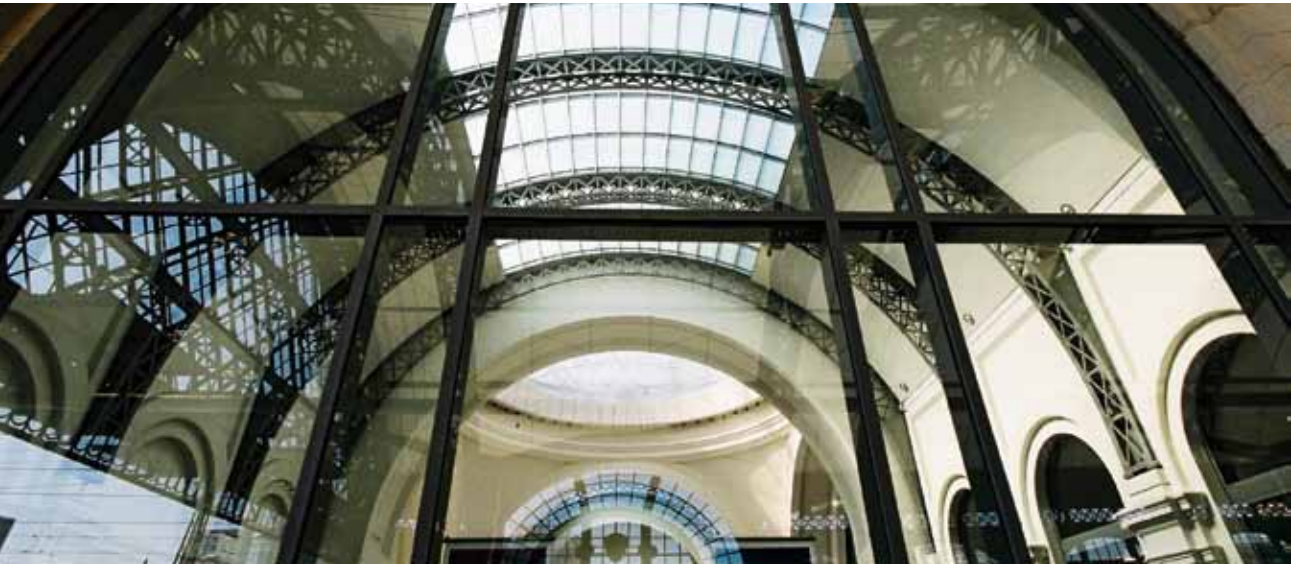
**Longitudinal passage**

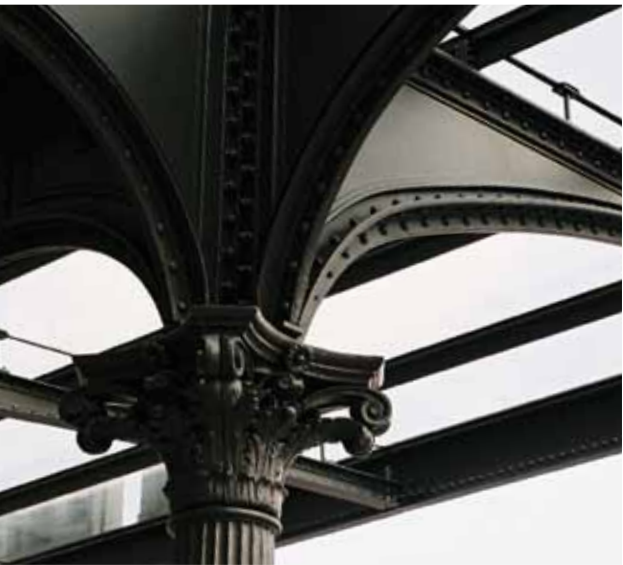
**Detailed knot canopy**
